JUNE 1978

**NASA Technical Paper 1210**

# **Light Airplane Crash Tests at Three Flight-Path Angles**

**Claude B. Castle and Emilio Alfaro-Bou**  
*Langley Research Center*  
*Hampton, Virginia*

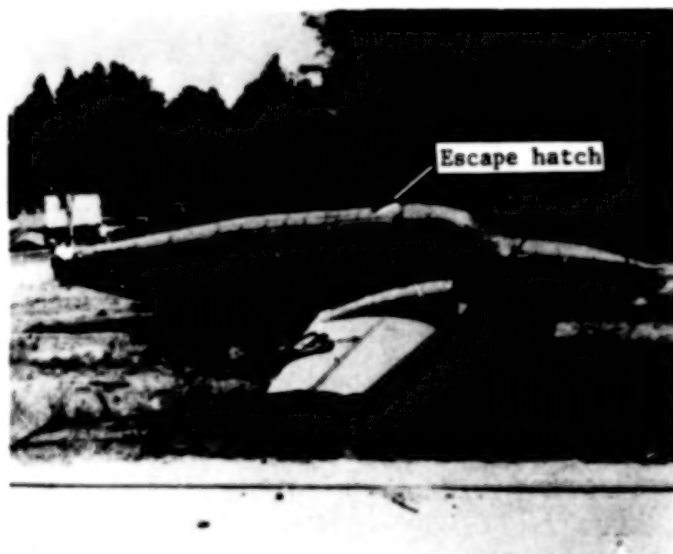
The exterior damage to the -15° test specimen is shown in figure 10. As seen in the overall view of the right side (fig. 10(a)), buckling occurred in the nose section, at the fire wall, and along the bottom of the fuselage. As shown in figures 10(c) and 10(d), there is rivet shear across the top of the fuselage aft of the pilot and copilot. Also, rivet shear is evident aft from the escape hatch along the window ledge and downward at the rear of the third window. (See figs. 10(a) and 10(b).) The breaking of the pilot's windshield and side window was due to deformation of the forward cabin section (fig. 10(a)).

(a) Overall view of right side.

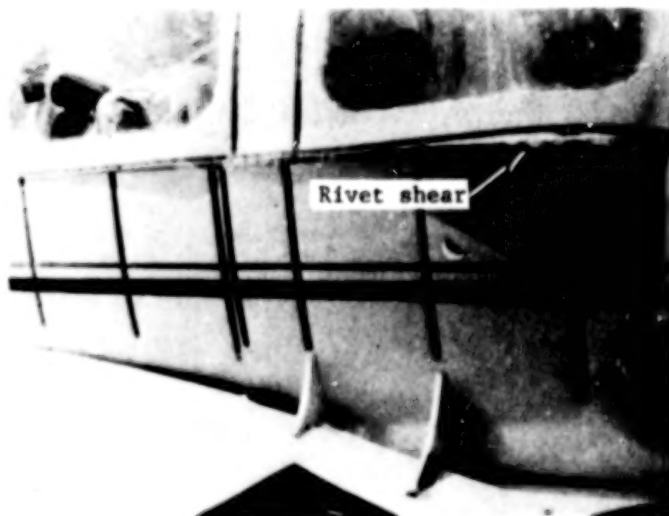
(c) Closeup view of left side.

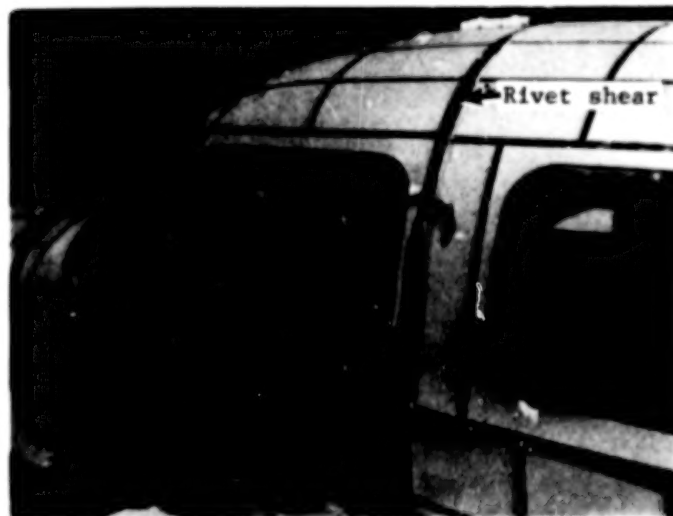
(d) Closeup view of left side and top of fuselage.

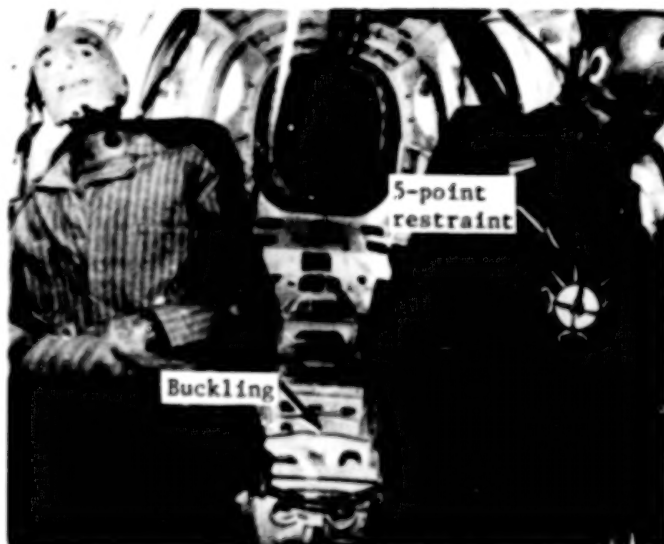
Damage to the cabin interior is shown in the four photographs of figure 11. The first photograph (fig. 11(a)) is a view looking aft from the cockpit where buckling can be seen in the stiffeners which tie together the two main floor beams. Figure 11(b) is a view looking forward from the tail section and again show the main floor beams and the buckled stiffeners. The four photographs of figure 11 also show the layout of seats, dummies, additional masses, and instrumentation equipment. The apparent upward movement of the floor section is shown by the outward rotation of the seats. The view looking through the doorway, figure 11(c), and the view of the cockpit, figure 11(d), show moderate interior damage.

(a) View looking rearward.

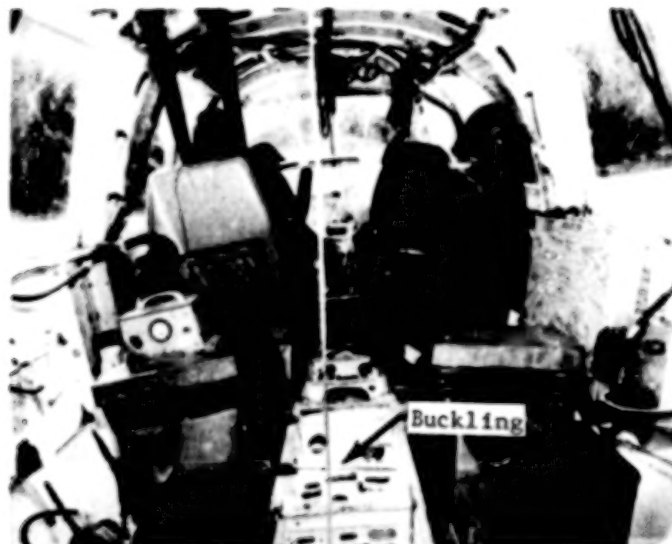
(b) View looking forward.

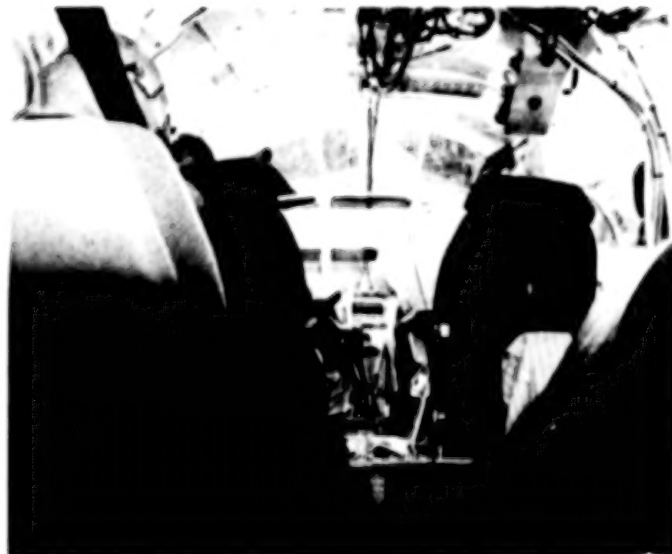
(d) View of cockpit area.

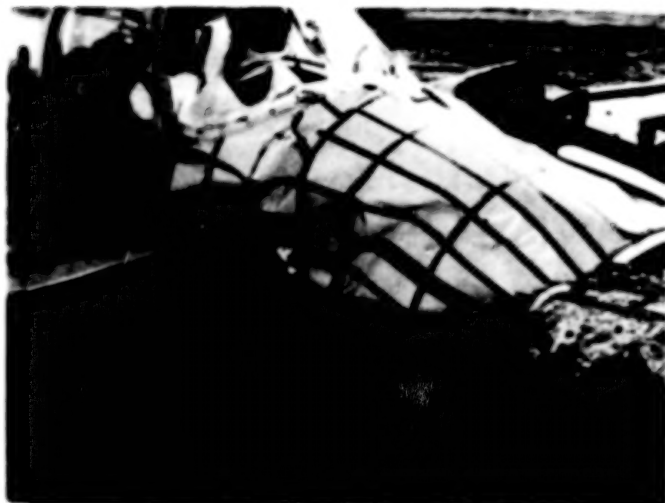
The exterior damage resulting from the crash is shown in figure 13. A view of the right side and nose section shown in figure 13(a) shows severe structural damage to the nose section, broken windshield, rivet shear, and cabin separation in the vicinity of the main spar aft of the pilot and copilot. Figures 13(b) and 13(c) are closeup views of the cabin on the right side, and figure 13(d) is a closeup view on the left side. Due to rivet shear, separation of the airframe occurred on the right side along the vertical edge of the emergency escape hatch (figs. 13(b) and 13(c)) and directly opposite on the left side (fig. 13(d)). There is rivet shear and skin separation across the top of the cabin at the rear of the escape hatch, and there is skin buckling along the roof of the cabin. Figure 13(d) shows the left side of the  $-30^\circ$  test specimen and the cabin separation along the window ledge, the broken windows, and the collapsed nose section. The windshield center post was fractured. The deformation, tearing, and buckling of the nose of the test specimen are quite visible. Aft of the fire wall, a livable volume was maintained inside the cabin.

(a) View of right side and nose.

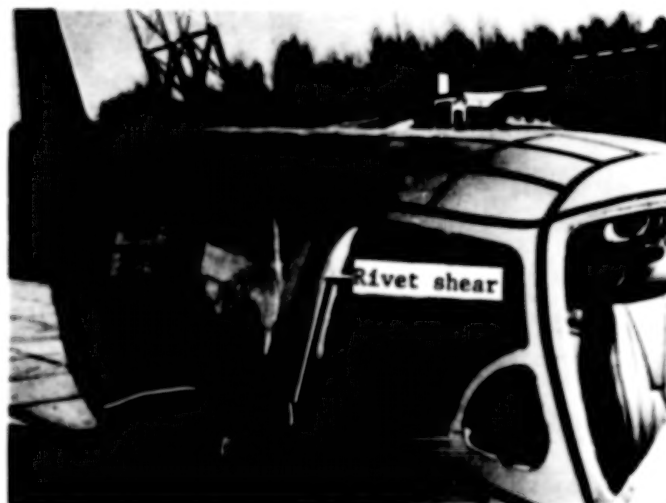
(b) Closeup view of cabin.

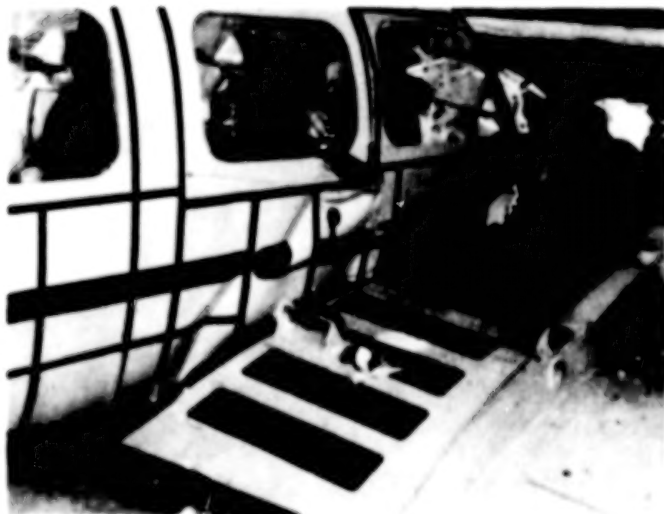
(c) View of right side.

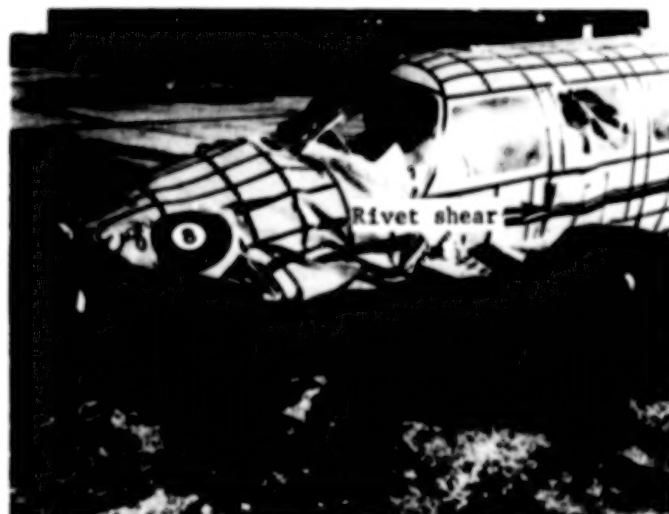
(d) View of left side, nose, and cabin.

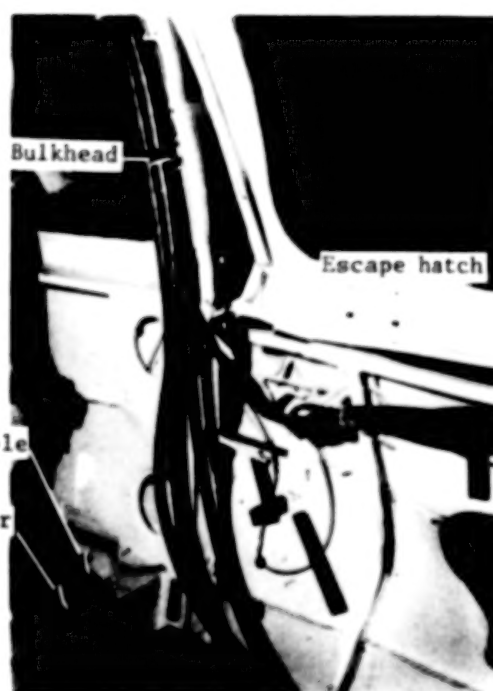
The interior damage to the  $-30^\circ$  test specimen is shown in figure 14. The view looking forward from the main spar (fig. 14(a)) shows the upheaval of the floor between the pilot and copilot, with deformed cross-frame and beam-member floor supports. The crew seats remained attached to the floor although the seat support structure on the pilot seat was broken. The steel cable attached to the copilot seat did not contribute to the support of the seat but was a precautionary measure to restrain the seat and dummy had the seat detached from its floor mounts. The separation of the skin along the cross-frame member in back of the main spar is shown in figure 14(b); this view is looking forward at the right side of the test specimen, with the displaced window being the emergency escape hatch. The floor and left side of the airplane in the vicinity of the first passenger are shown in figure 14(c). The floor cross-frame supports are bent but attached, and there are buckles in the cross frame about seat-pan level along the left side. Also shown are the broken passenger window and the separation of the cabin along the window level. Figure 14(d) shows an overall view looking forward from the area behind the door. The third-passenger seat was deformed because of the apparent upward movement of the floor during the tail slapdown. (See fig. 12(h).) The cross-member supports between the two main longitudinal floor beams pulled loose from the left beam (fig. 14). In the first-passenger location, the forward movement of the dummy produced a sufficient load on the shoulder restraint system to cause tearing of the airframe structure supporting the inertial reel.

(b) View of right side at main spar.

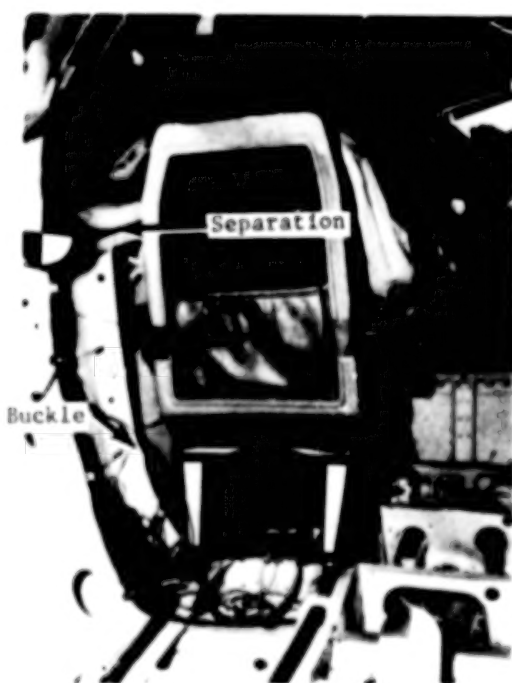
(c) View of floor and left side.

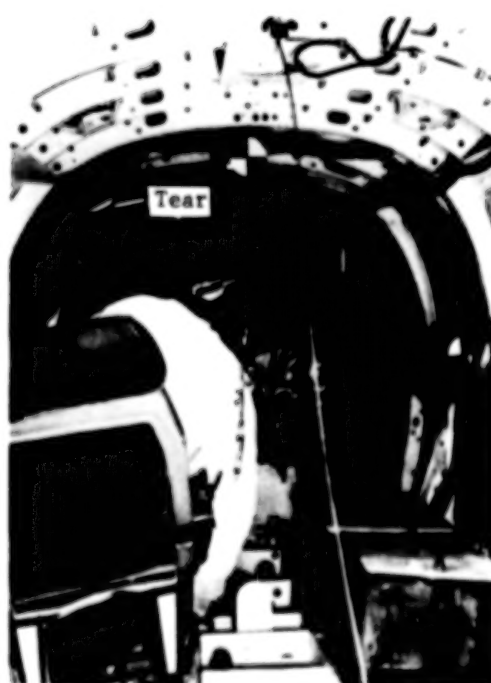
(d) View looking forward in cabin area.

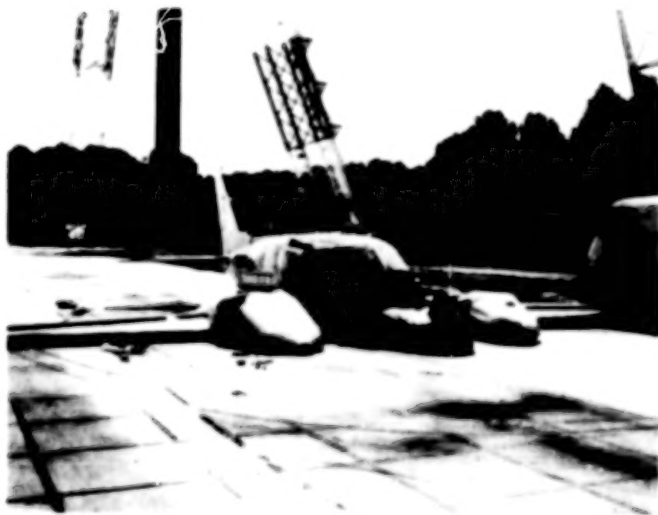
The crash damage to the exterior of the  $-45^{\circ}$  test specimen is shown in figure 16. An overall view of the right front side of the airplane is shown in figure 16(a) which shows the nose demolished, the windshield broken, the windshield post broken both in the center and right side, the damaged nacelle covering, and the crease across the top of the cabin section where inward folding of the roof section has taken place. Figure 16(b) is a closeup view of the right side and shows the wing-to-cabin deformation, the breakaway of the emergency escape hatch, the separation of cabin and nose section at the fire wall, and the fuel leakage. Fuel leakage occurred in both fuel tanks because of the wing structure piercing the fuel bladders. Figure 16(c) shows the cabin section from the left side and shows the fracture of the left windshield post and collapse of the first main-section frame at window level. Also shown is rivet shear along the window ledge and across the top of the cabin. Figure 16(d) is another view of the damaged cabin discussed in the previous figure (fig. 16(c)) and clearly shows the roof crease. Safety glass was used on the left windshield and plexiglass was used on the right windshield. The fragmentation pattern for both sides is shown in figure 16.

(a) Overall view of right front side.

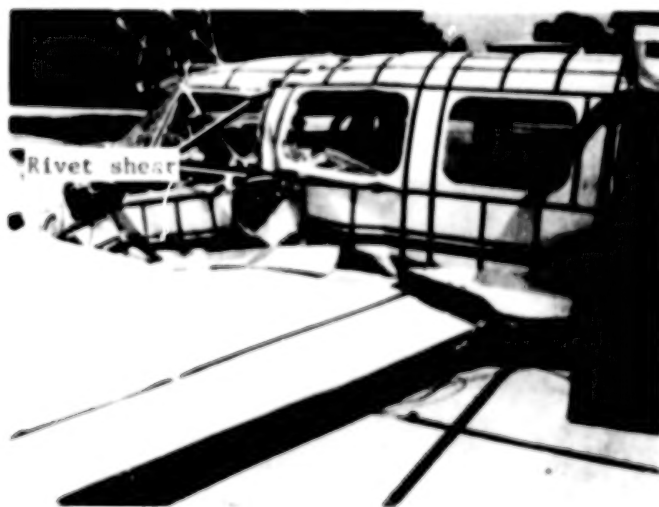
(c) View of left side of cabin.

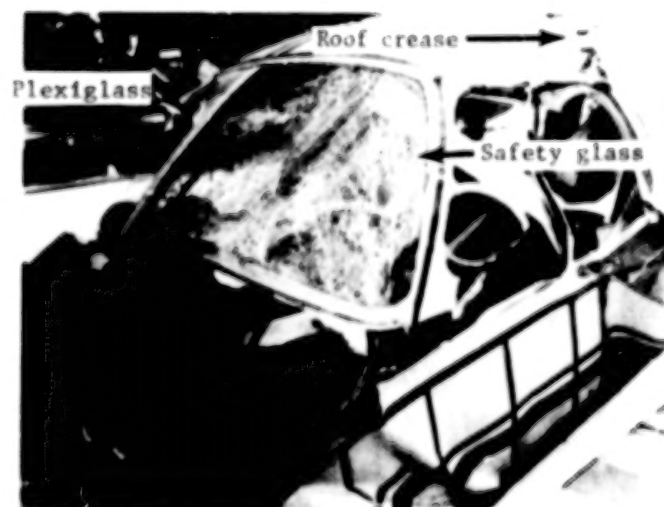
(d) Closeup view of cabin.

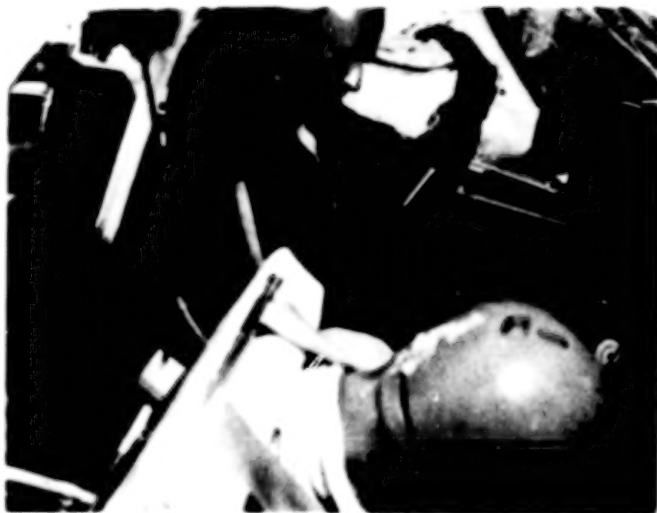
Interior cabin damage to the  $-45^{\circ}$  test specimen is shown in figure 17. A view of the pilot and copilot section of the cabin (fig. 17(a)) shows the instrument panel displaced upward and the control wheel shaft broken, with the control wheel bearing on the pilot's chest. The roof impacted the head rest on the pilot seat to deform it forward, causing the dummy pilot's chin to rest on its chest. The upheaval of the cabin-floor section thrust the dummy copilot forward into the instrument panel. Figure 17(b) shows a view through the cabin door looking at the rear of the third-passenger seat. The forward motion of the third passenger during impact caused the rear seat legs of the third-passenger seat to break loose from the seat rails, as shown. The seat back is broken and the dummy's arm is visible resting in the aisle. Motion-picture coverage of the interior (see film supplement) indicates that the third seat was broken during the second impact.

(a) View of crew and cockpit.

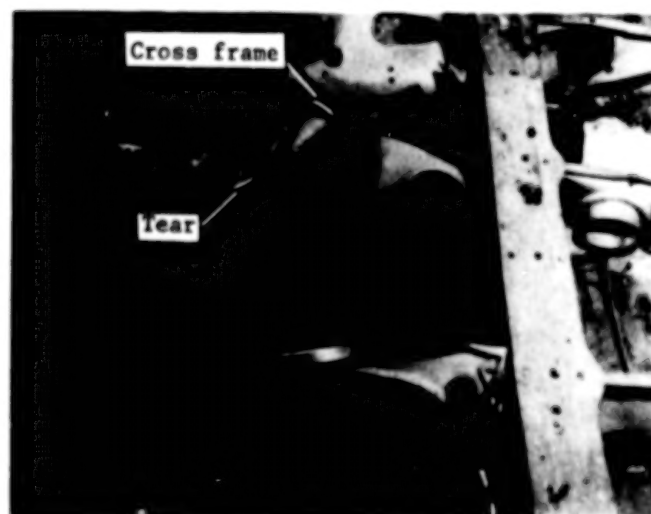
The type of subfloor structural failure can be seen in the overall (fig. 17(c)) and closeup (fig. 17(d)) photographs. In figure 17(c) is shown the rivet shear along the side wall and between the cross sheet-metal frames and the longitudinal floor beams. Tearing of the sheet-metal frames is evident along the entire length of the cabin area. The closeup view (fig. 17(d)) shows the sheared rivets lying on the outer skin and the mangled cross frame structure.

(d) Closeup view of floor structure.
